Beavertail Creek

At Prentiss Bay Road (lower crossing)
BVR-3

Site I.D.: BVR-3

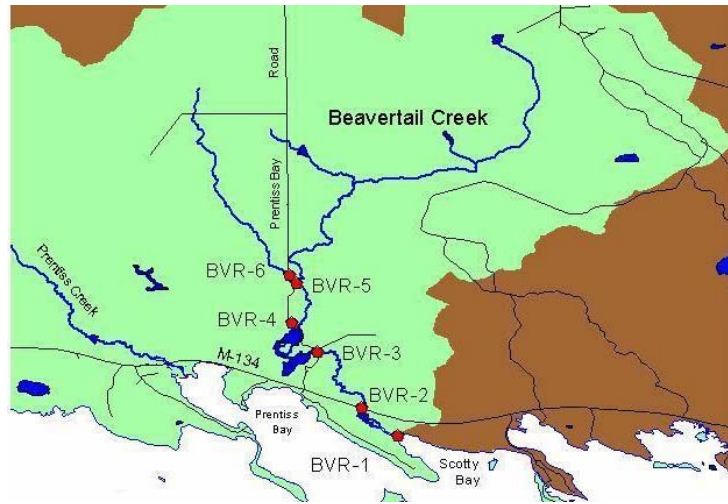
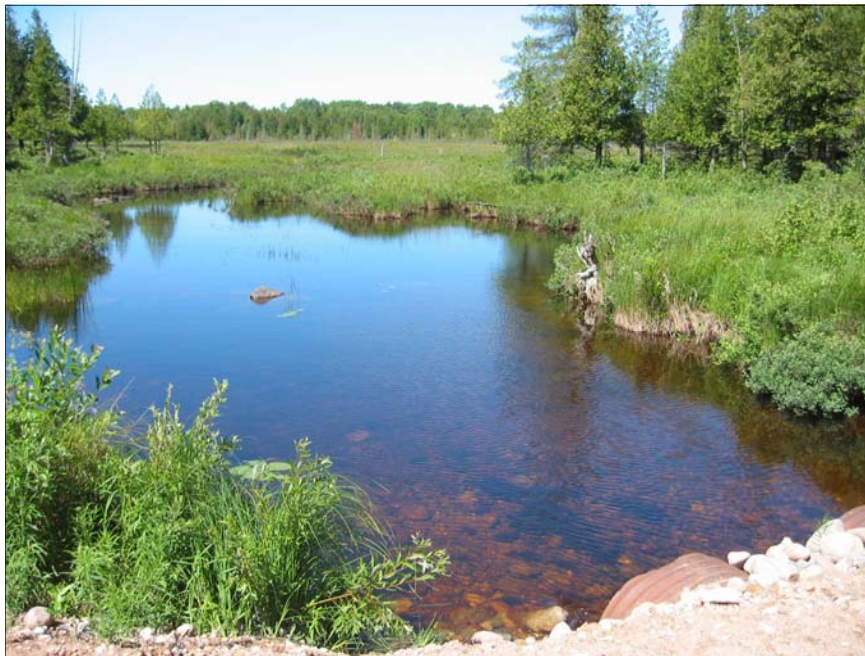
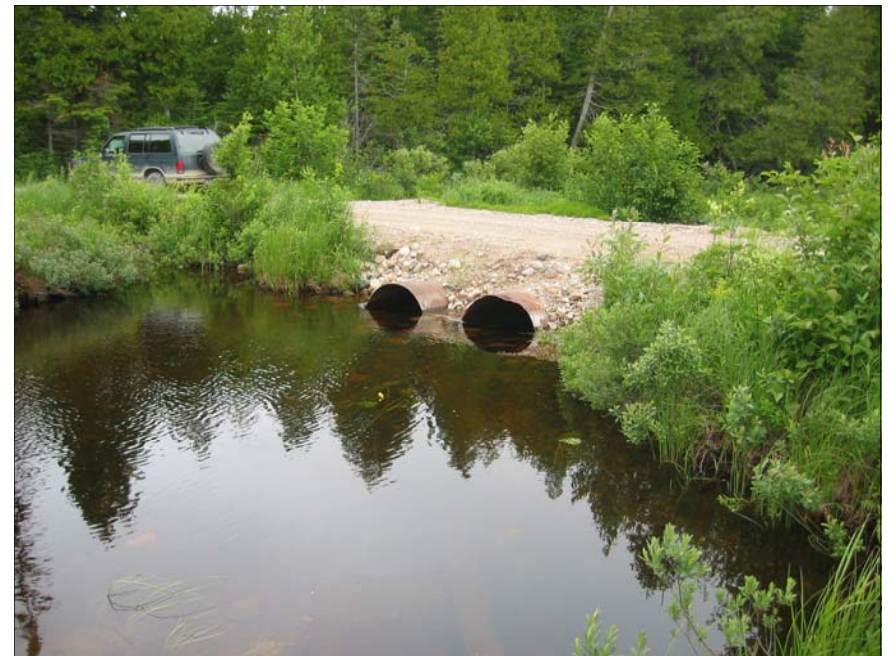
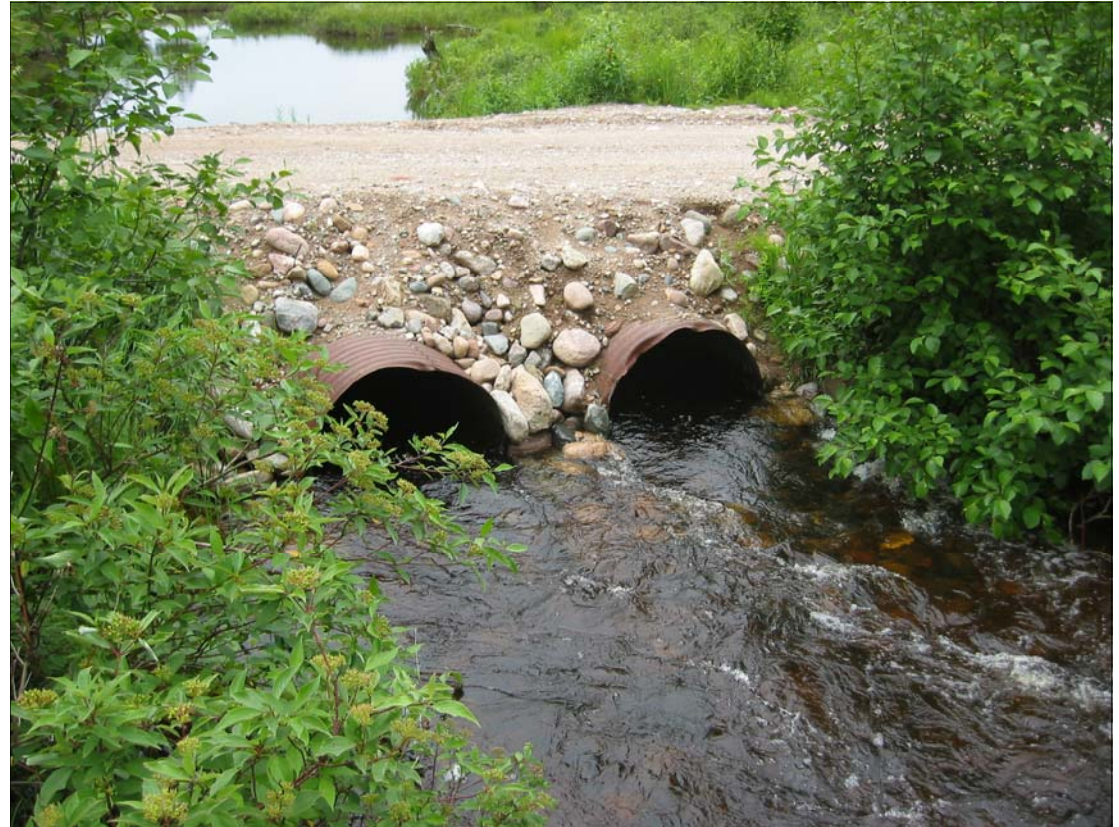
- Streambank erosion beside crossing
- Embankment erosion
- Culvert outlet erosion
- Sand/soil over crossing

Erosion Severity Rating: Moderate (25)

Overall Condition Rating: Severe

Comments: This is the most downstream crossing on Prentiss Bay Road and possibly the most impacted by poor design. The crossing was nearly impassible the first spring of the Les Cheneaux Watershed Project due to heavy flows impeded by the two ineffective culverts. The gravel surface over the culverts was washed out. These culverts need to be replaced by a bridge or large bottomless culvert that accommodates the creek width. The road approaches need to be raised and embankments stabilized with vegetation. Each year approximately 6.6 tons of sand is deposited in the creek at spring discharge. (8 ft wide + 8 ft wide gully/2 x 1 ft deep x 15 ft long x .055 tons/cu. ft.)

- Replace culverts with single bottomless culvert or bridge
- Raise approaches
- Stabilize embankments

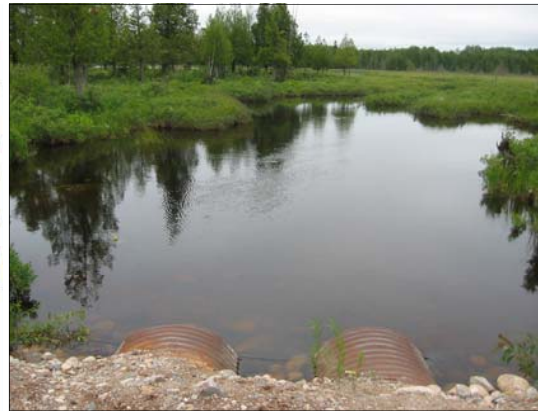
Upstream

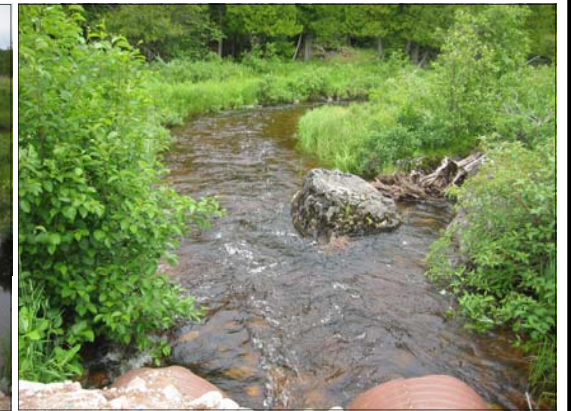
Downstream
