Beavertail Creek

At Prentiss Bay Road (second crossing)
BVR-4

Beavertail Creek at Prentiss Bay Road (second crossing)

Site I.D.: BVR-4

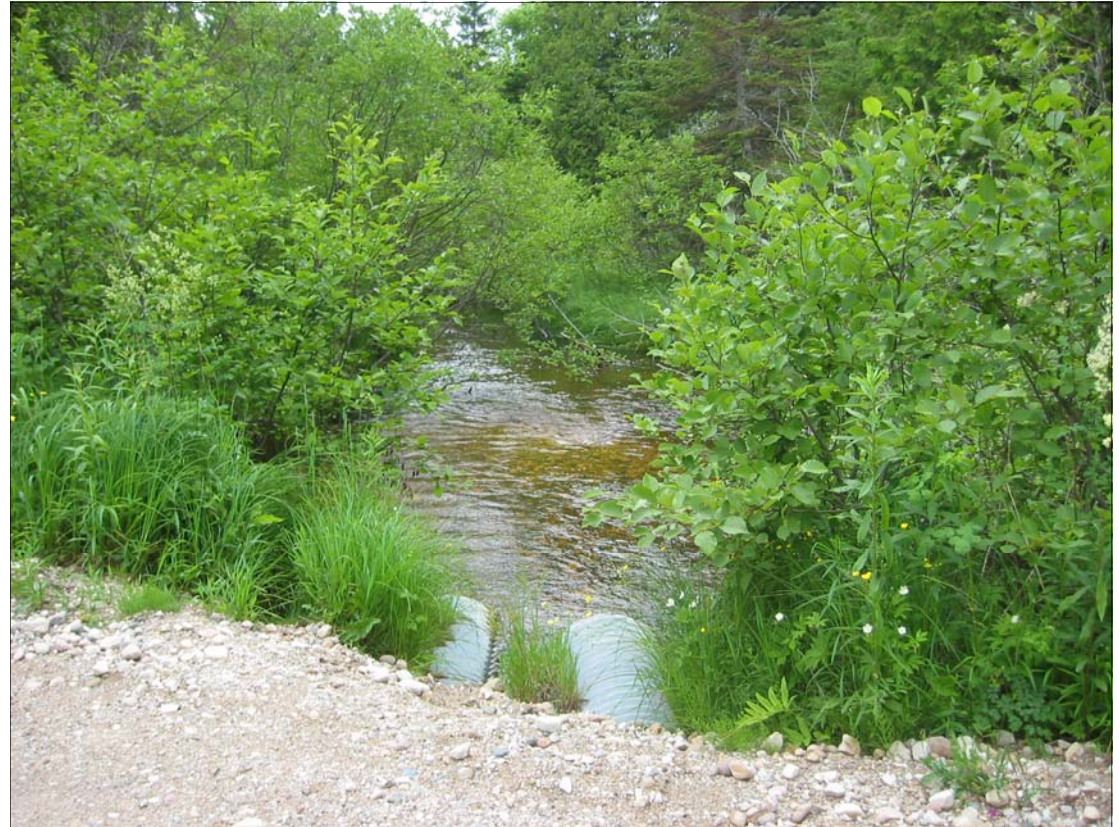
- Embankment erosion
- Culvert outlet erosion
- Pool formation at culvert outlet
- Sand/soil over crossing

Comments: During the spring of both years of the Les Cheneaux Watershed Project, this crossing on Prentiss Bay Road has flooded over the road, cutting a channel over the road and depositing significant sediment into the creek. The road is very low. Three small culverts are installed at an angle to the road, impacting the natural stream flow. Improvement to this crossing would include raising the road above the surrounding grade and stabilizing the embankments with vegetation. A bridge or large bottomless culvert would be added to maintain the natural flow pattern and eliminate erosion around the current culverts. 4.125 tons of sediment are deposited into the creek each year because of an annual wash out of the road. (5 ft wide + 5 ft wide gully/2 x 1 ft deep x 15 ft long x .055 tons/cu. ft)

- Replace culverts with single bottomless culvert or bridge
- Raise road elevation
- Stabilize embankment with vegetation
