Cedarville Creek

at M-134
CED-2

Site I.D.: CED-2

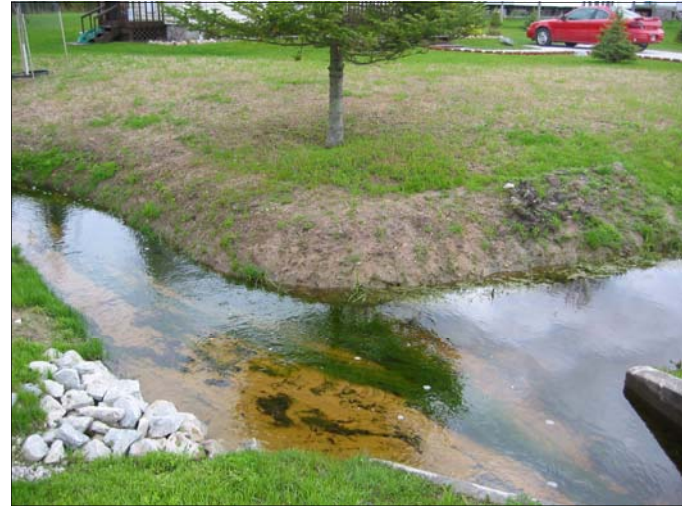
- Streambank erosion beside crossing

Erosion Severity Rating: Moderate (18)

Comments: All riparian areas of Cedarville Creek north of and adjacent to M-134 need additional vegetation to stabilize stream banks. Erosion = 100 ft. long x 2 ft high x .05 ft/yr x .055 = .55 tons/yr

Unstable streambank on north side of M-134

- Stabilize stream bank with vegetation
- Install buffer

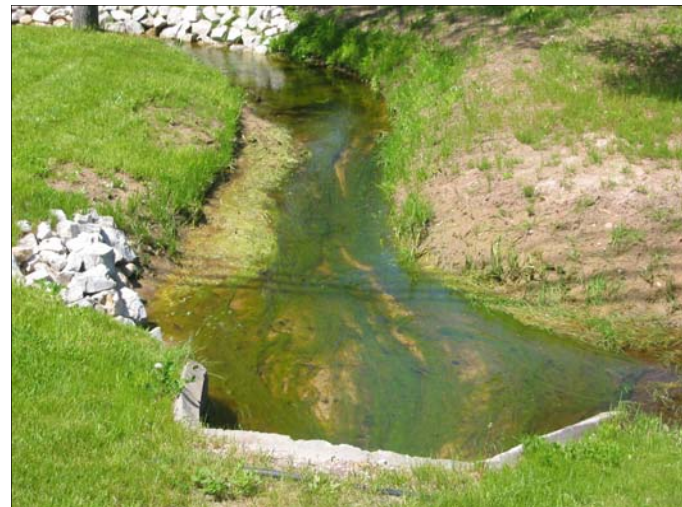
Heavy growth of filamentous algae north of M-134
