# Flowers Creek

At Flowers Bay Road (north)  
FLR-3

**Flowers Creek at Flowers Bay Road (north crossing)**

**Site I.D.:** FLR-3

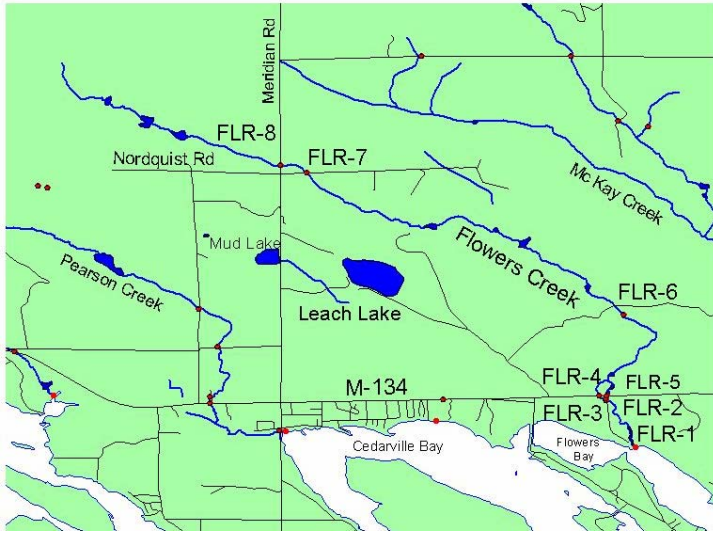
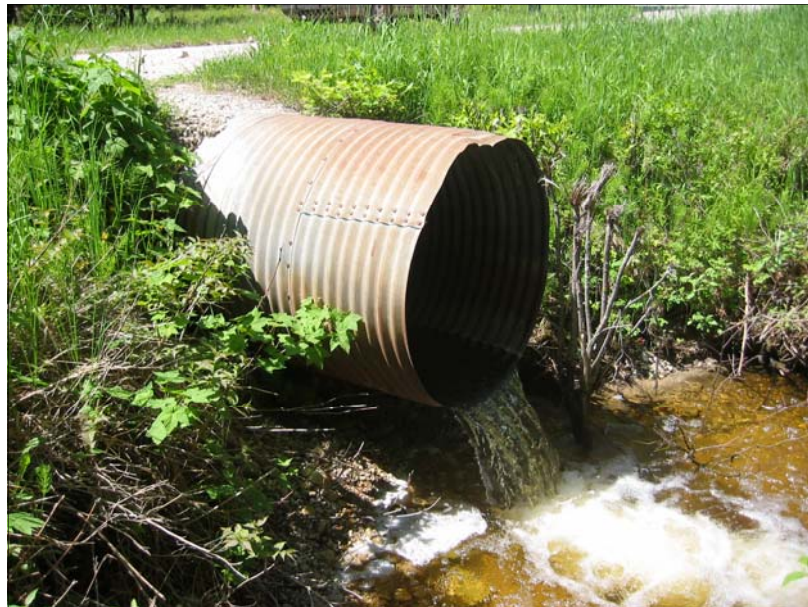
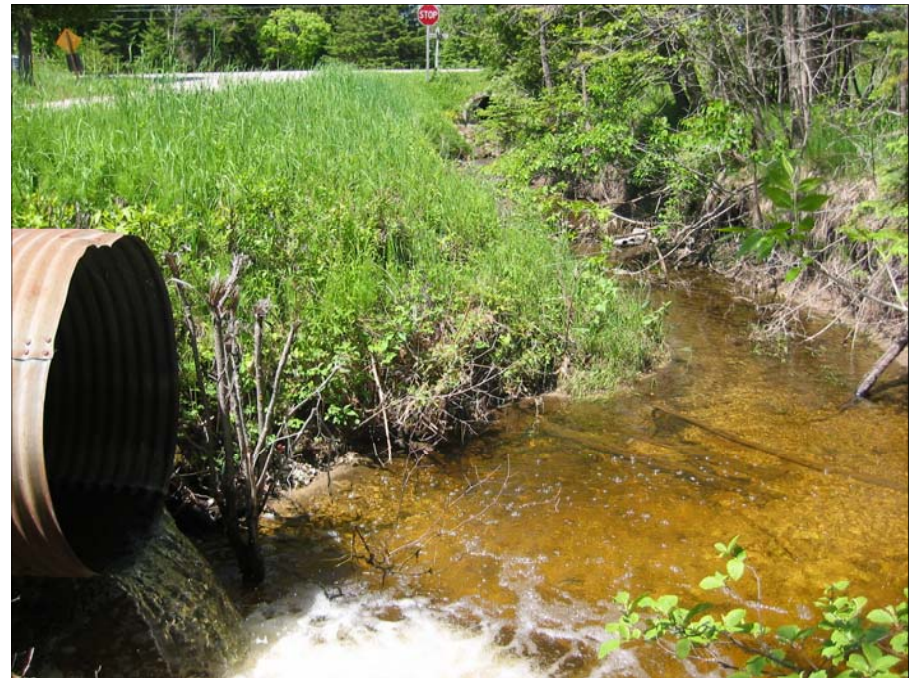
**Fish Passage Problem:** Yes—perched

- Streambank erosion beside crossing
- Pool formation at culvert outlet
- Sand/soil over crossing

**Comments:** This culvert serves the main creek channel, but it is perched to the extent that the main discharge diverts away from it and along Flower Bay Road to cross through FLR-2. The culvert at this location (FLR-3) needs to be removed and replaced with a larger, bottomless culvert and the riparian vegetation near the crossing restored to stabilize the entire crossing. Structures should be installed along Flower Bay Road to divert road runoff into vegetated ditches before entering the creek.

- Replace culvert with bottomless culvert or bridge
- Restore vegetation to stabilize crossing
- Install structures to divert road runoff into ditches
- Stabilize lower streambank
