# McKay Creek

At M-134  
MCK-2

**McKay Creek at M-134**

**Site I.D.:** MCK-2

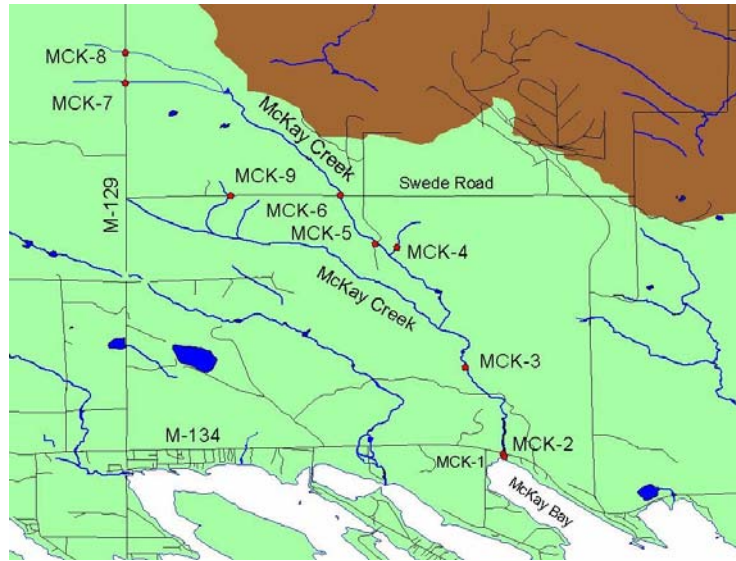
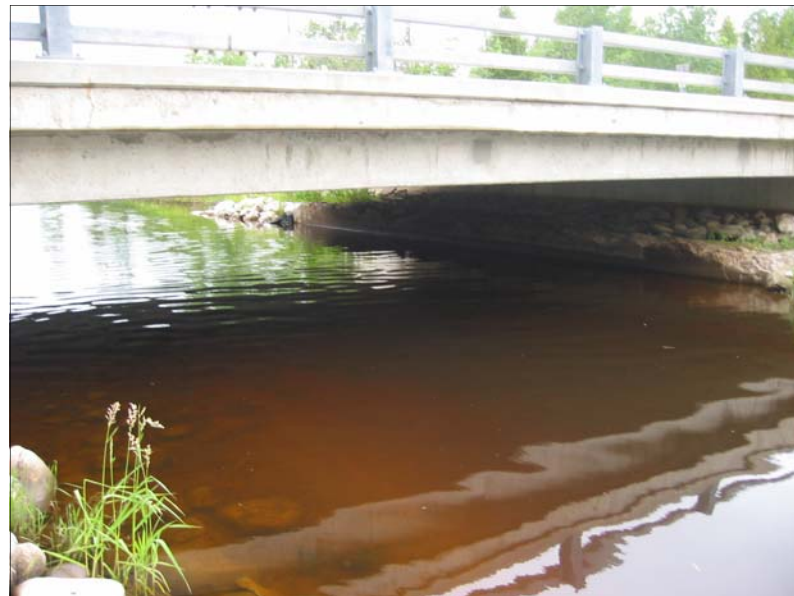
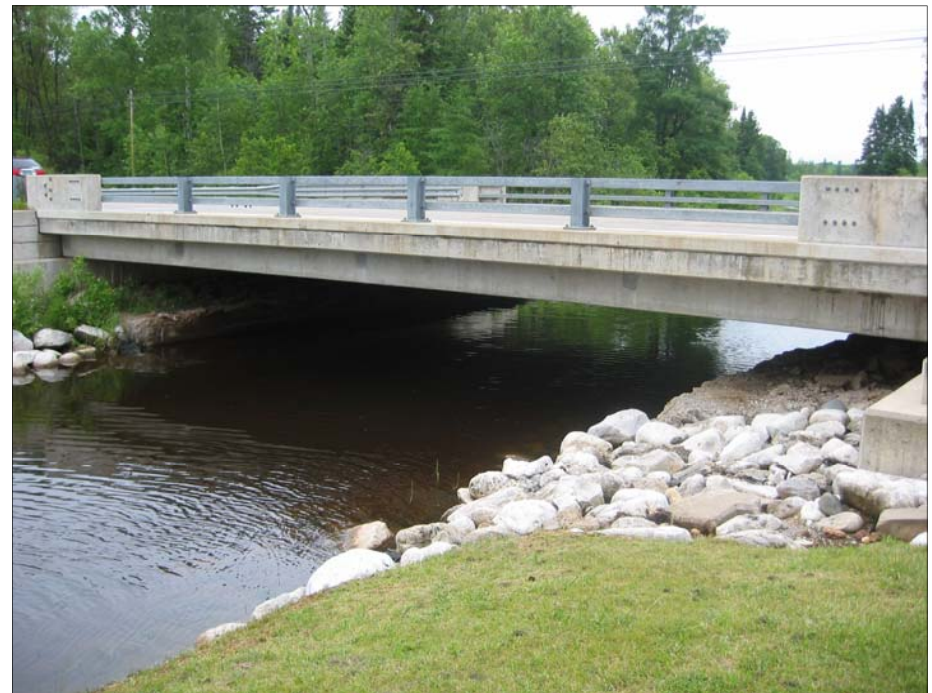
- Slight  $200 \text{ ft} \times 3 \text{ ft} \times .010 \text{ ft/yr} \times .055 = 0.33 \text{ tons/yr}$

**Erosion Severity Rating:** Moderate (15)

**Overall Condition Rating:** Minor

- Revegetate banks
