McKay Creek

At Swede Road (west)
MCK-9

McKay Creek at Swede Road (west—tributary)

Site I.D.: MCK-9

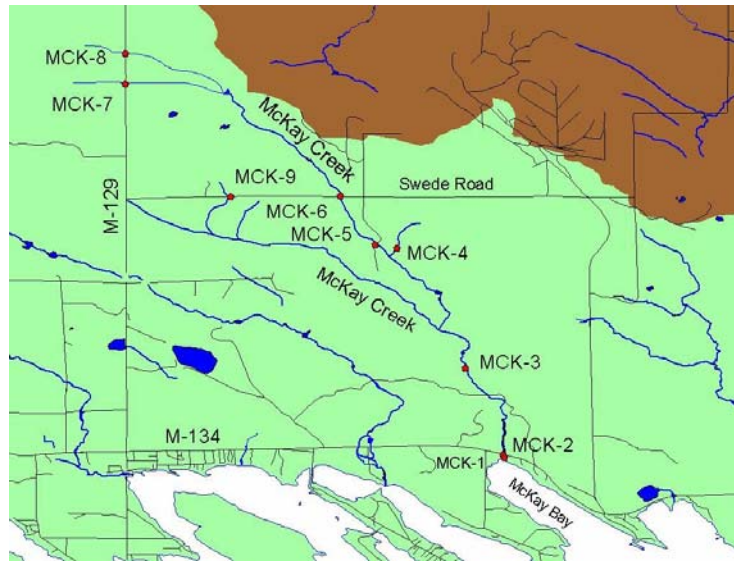
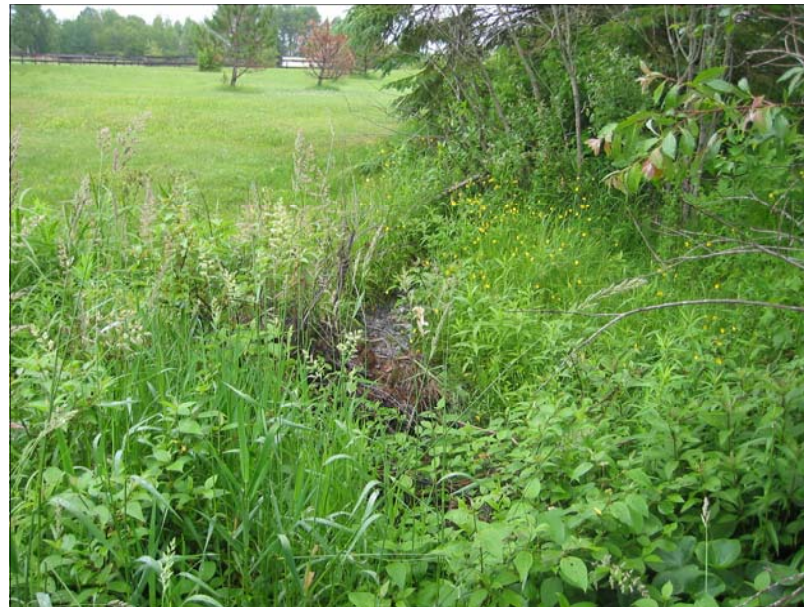
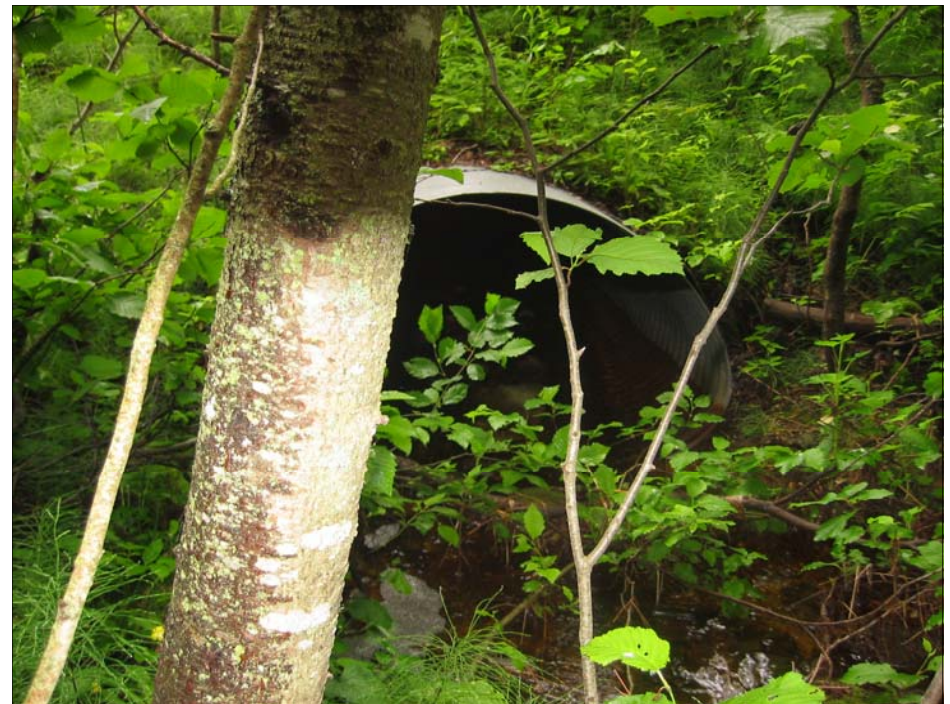
- Embankment erosion

Erosion Severity Rating: Moderate (18)

- Replace culvert with bottomless culvert or bridge
