Prentiss Creek

At Quarry Grade Road
PRN-5

Prentiss Creek at Quarry Grad Road

Site I.D.: PRN-5

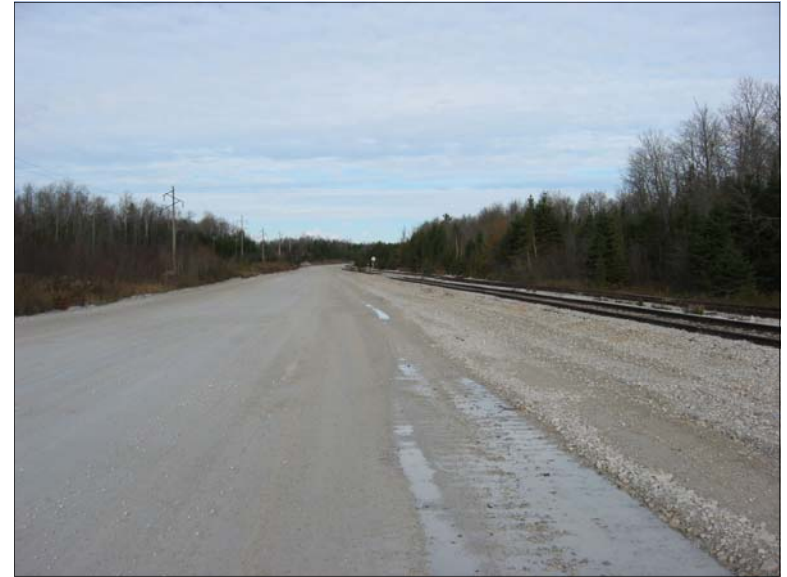
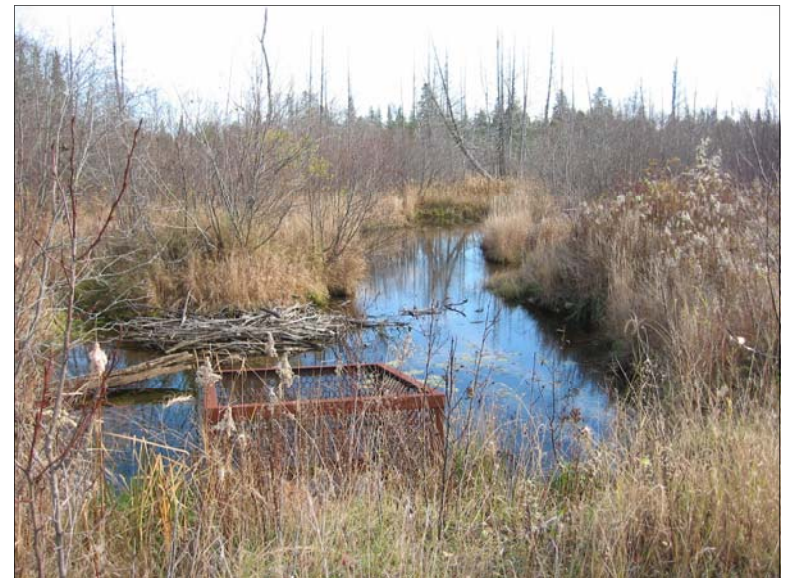
- Embankment erosion
- Sand/soil over crossing

Erosion Severity Rating: Moderate (21)

Overall Condition Rating: Severe

Comments: The southern-most branch of Prentiss Creek begins west of the MLO quarry grade. The creek crosses under the grade and the train tracks used by MLO. The culvert is small and protected from blockage by square cages at the crossing inlet and outlet. This cage prevents debris from being lodged within the long span under both the grade and the train route. An alternate crossing structure should be researched; if not possible, the cage should be kept clean to maintain natural drainage patterns. A protective embankment should also be maintained to minimize sediment reaching the water body.

- Investigate alternate crossing structure
- Clean and maintain inlet and outlet cages
- Maintain protective embankment
