# Pearson Creek

at Meridian Road  
PRS-2

**Site I.D.:** PRS-2

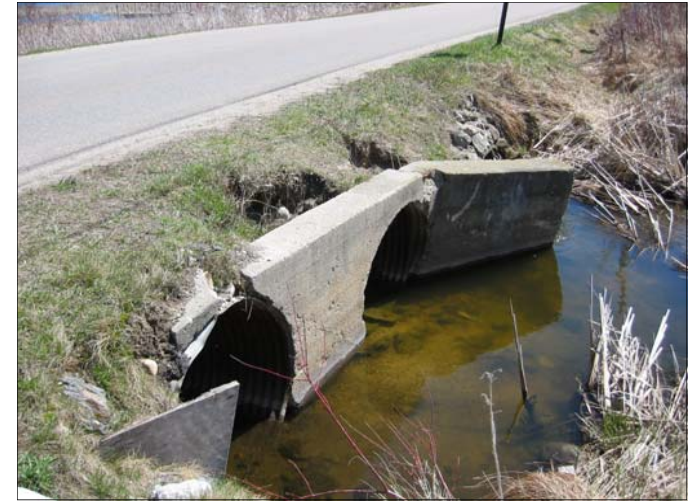
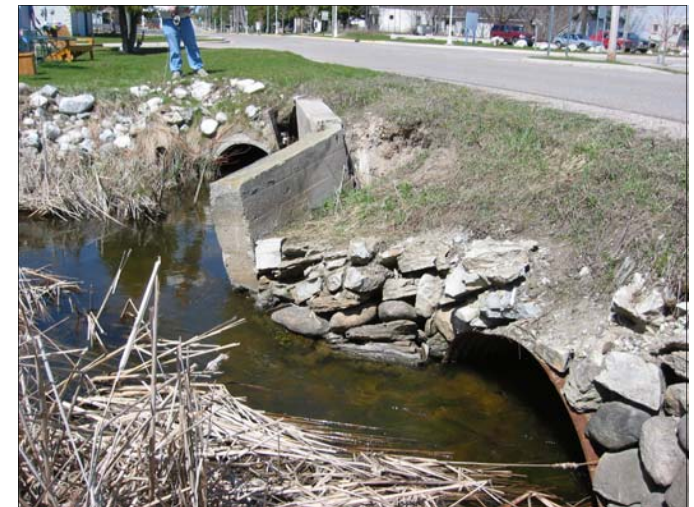
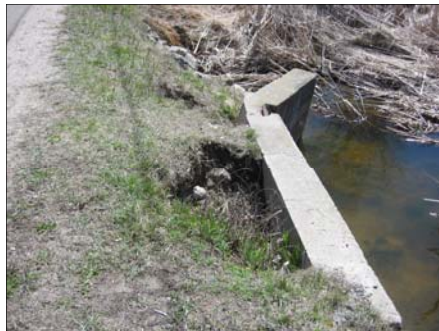
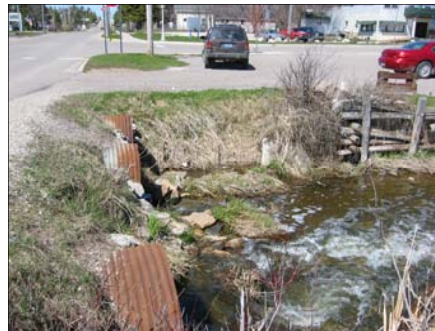
- Streambank erosion beside crossing
- Embankment erosion

**Comments:** Pearson Creek is suffering the negative impacts of the Meridian Road crossing in downtown Cedarville. The crossing has three separated, perched culverts in which the upstream concrete embankment is separating from the roadside embankment, creating both a hazard to pedestrian and vehicular traffic as well as an erosion site. The north side stream bank on the downstream side is a vertical wall stabilized with weathered cedar posts. This riparian area, which is now a restaurant parking lot, is also in danger of collapsing and depositing sediment into the creek mouth. The preferred treatment at this site would be a bridge that would have walking access across the creek with a future pedestrian structure providing safe walking from the downtown area to the public boat launch and parking area. 2 ft wide gully(top) + 1 ft at bottom/2 x .5 ft. deep x 10 feet long x .055 tons/cu.ft. / 10 years = .0275

- Replace culverts with bridge with pedestrian/bicycle accommodation
- Reshape and stabilize
