# Pearson Creek

at M-134  
PRS-3

**Site I.D.:** PRS-3

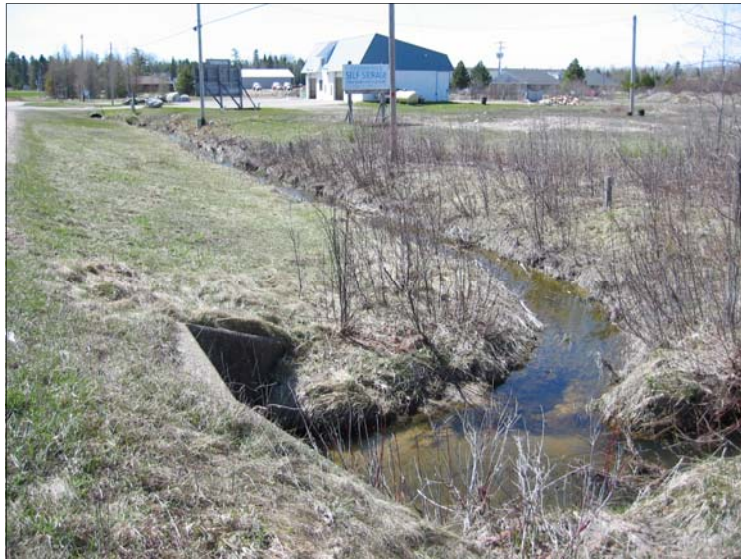
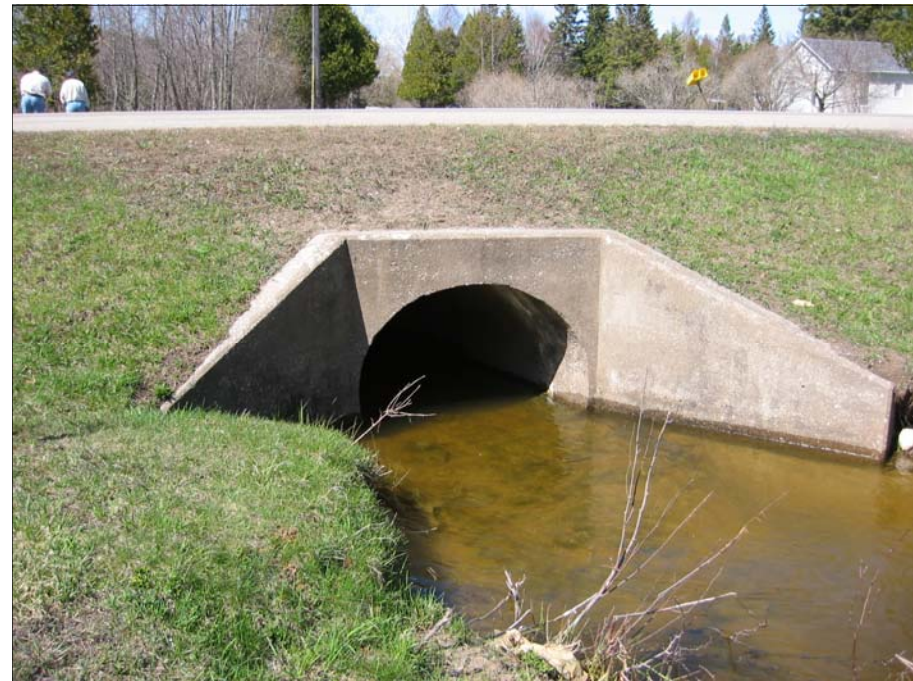
- Blindline Road erodes during heavy rains. Roadside ditch provides unabated path for stormwater into Pearson Creek.

**Erosion Severity Rating:** Moderate (15)**Overall Condition Rating:** Minor**Cost:** See BMP Cost Tables**Comments:** 4 ft top width + 1 ft bottom width/2 x 2ft deep x 2640ft long x .035 tons/cu.ft. /15 years = 31 tons/year

- Maintain heavy vegetation in ditch along with check dams
