Pearson Creek

at State Road
PRS-5

Site I.D.: PRS-5

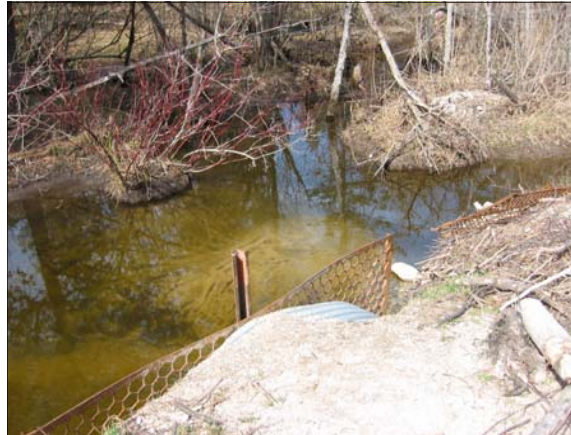
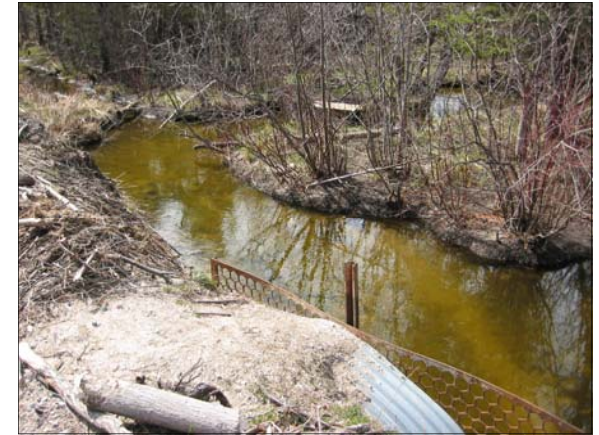
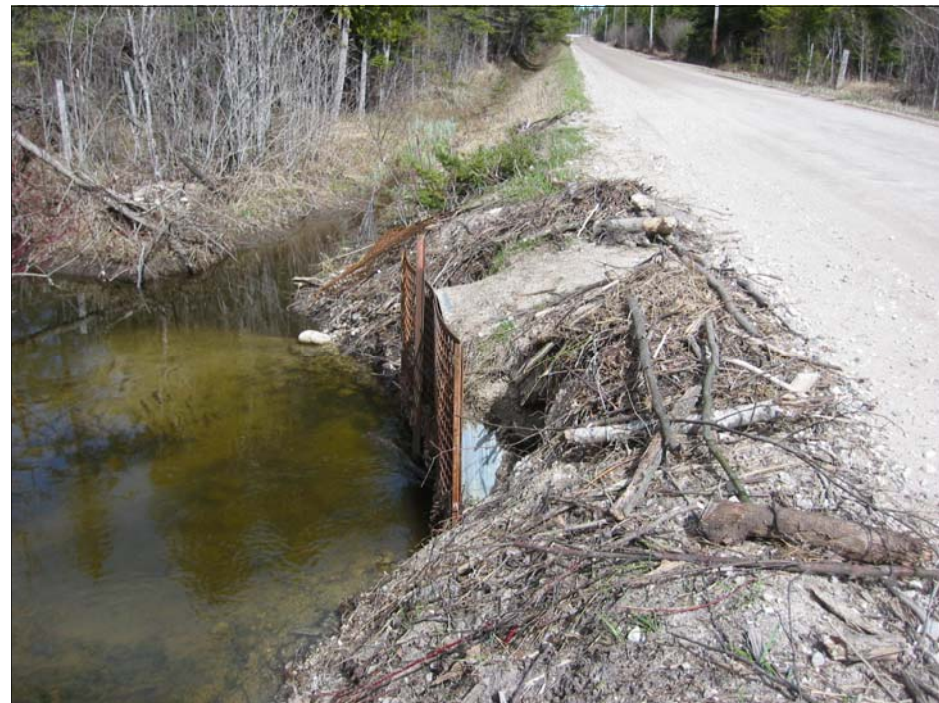
- Streambank erosion beside crossing
- Embankment erosion
- Culvert outlet erosion
- Shoulder/ditch erosion
- Sand/soil over crossing

Erosion Severity Rating: Severe (32)

Overall Condition Rating: Severe

- Replace culvert with bridge or bottomless culvert
- Raise the road elevation
- Raise the approach elevations
- Restore ditch vegetation
- Install diversion outlets
- Install rip-rap

Comments: It is recommended that a bridge or bottomless culvert large enough to accommodate natural creek channel be constructed at this location. The road over the bridge and at approaches should be raised and paved with structures installed to allow water to runoff road into vegetated ditches before reaching the creek. The stream bank on the north side of State Road needs to be restored with vegetation and possibly rip-rap. 10 ft long x 3 ft high x .01 ft/yr x .055 tons/cu.ft. = .165 tons/year
