Pearson Creek

Northwest Tributary at the Snowmobile Trail
PRS-8

Pearson Creek (NW Tributary) at Snowmobile Trail

Site I.D.: PRS-8

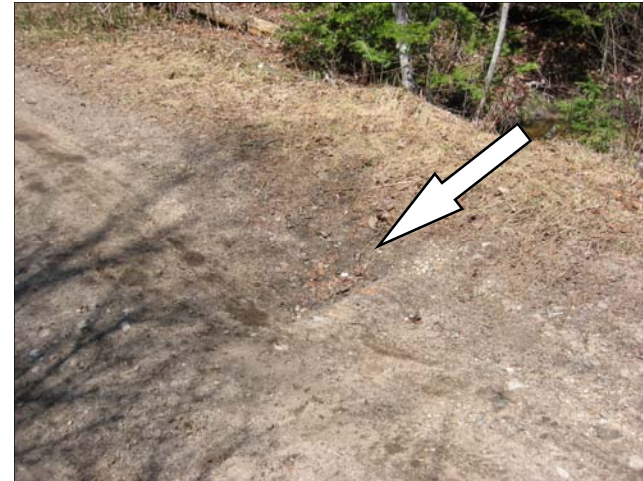
Condition: Poor

Culvert Flow: Obstructed

Exposed culvert.

- Replace culvert with larger bottomless culvert
- Increase length of culvert
- Stabilize embankment
- Install runoff diversions
- Revegetate
- Raise approaches

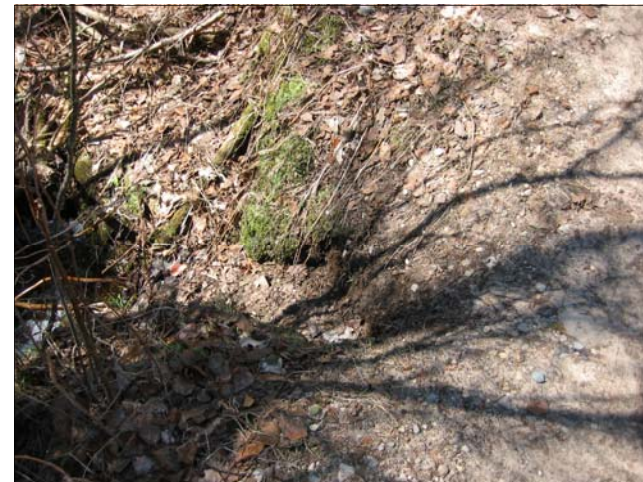
Comments: The road over this tributary is eroding away each time increased spring, fall, and rain event flows dam at this crossing. The culvert should be replaced with a larger, bottomless culvert to accommodate the natural course of the tributary. The length of the culvert should be increased to protect from road dirt to reach the tributary at the crossing. The approaches should be installed with runoff diversions so the road doesn't provide an easy route for runoff into the tributary. 10 ft long x 2 ft high x .03 ft/yr x .055 tons/cu. ft. = .03 tons/yr

Eroded shoulder. Stream flow has eroded the soil away from the culvert inlet undermining the trail bed.
