Steeles Creek

At Schneider Crossing (Czech Road)
STL-5

Site I.D.: STL-5

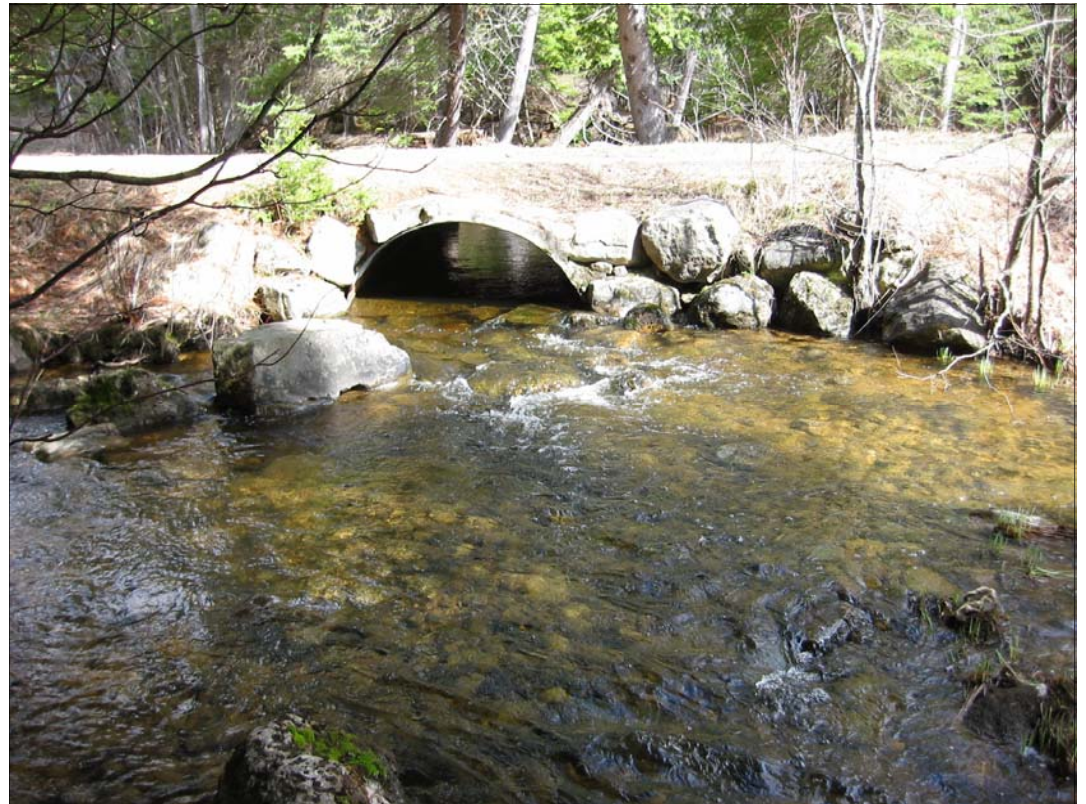
- Pool formation at culvert outlet
- Sand/soil over crossing

Erosion Severity Rating: Moderate (22)

Comments: The culvert at this crossing is too small for spring and fall flows. This is a high gradient area with quality riffle habitat below the crossing. The small culvert provides a bottleneck promoting blockage.

- None
