Flowers Creek

at Snowmobile Trail Crossing
FLR-6

Flowers Creek at Snowmobile Trail Crossing

Site I.D.: FLR-6

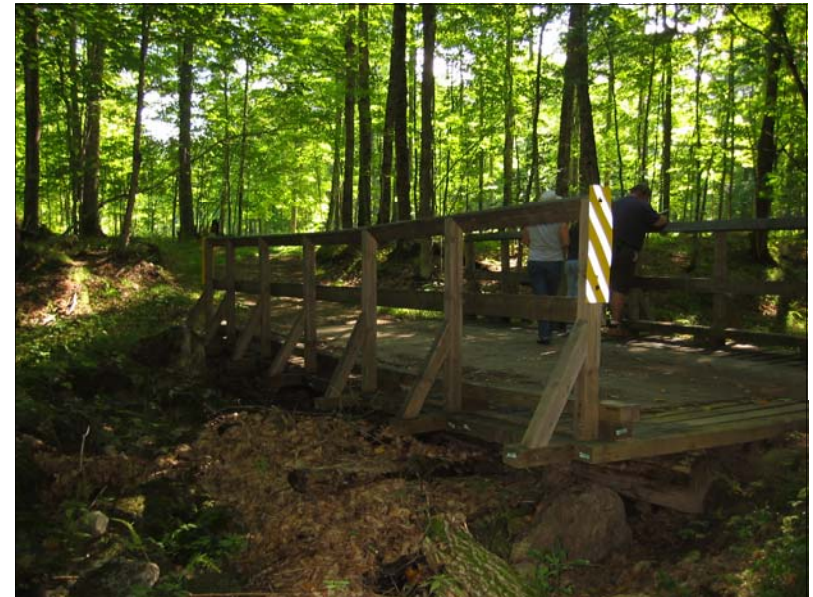
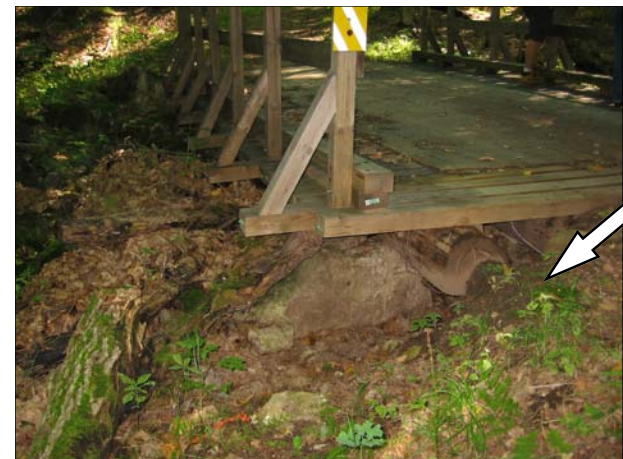
- Embankment erosion
- Culvert outlet erosion
- Pool formation
- Sand/soil over bridge

Comments: During heavy stream flow periods such as the spring thaw, water flows around the ends of the bridge and washes away the trail at the foot of the bridge. The base of the structure is very close to the stream bed. To correct this problem, the bridge should be lengthened and raised above the creek. Measures should be taken to stabilize the embankment and the approaches. Sediment load has been calculated as 1 ft wide x 9 ft long x .05 ft/yr x 0.055 tons/cu.ft = .0248 tons/yr.

Eroded approach to the bridge.

- Lengthen bridge
- Raise approaches and bridge
- Stabilize embankments
- Stabilize approaches
