McKay Creek

At Crockett Bridge
MCK-5

Site I.D.: MCK-5

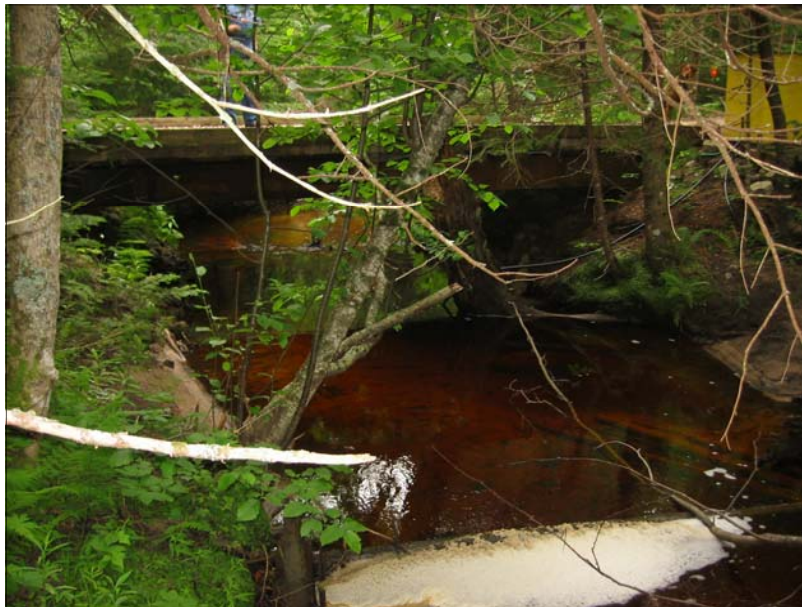
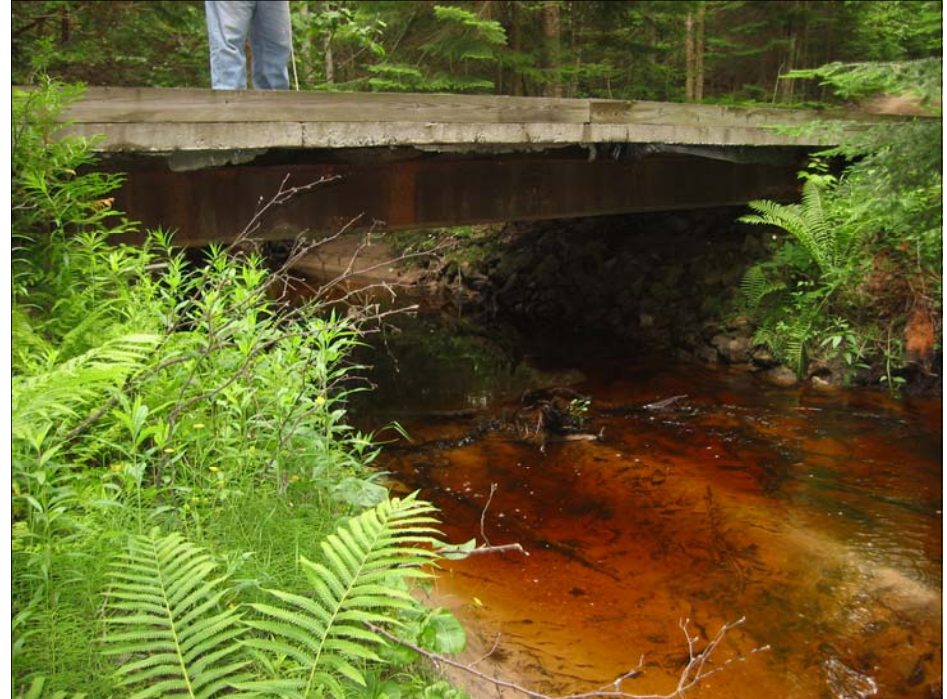
At Crockett Bridge
MCK-5**Conditions and Treatment****Erosion Conditions**

Erosion Severity Rating: Moderate (20)**Overall Condition Rating:** Moderate**Cost:** See BMP Cost Tables

Recommended Treatment

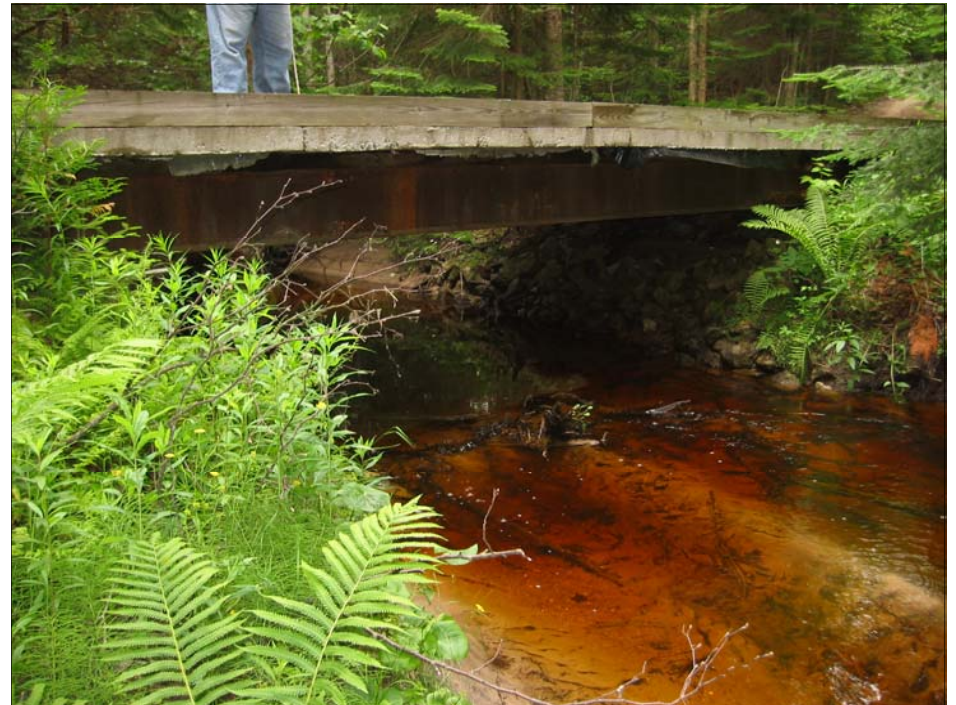
- Sand/soil over bridge

Comments: Both approaches to Crockett's bridge should be improved to eliminate the current path of sediment from coursing down the road and reaching the creek. The road should be raised and significantly crowned and turnouts installed to divert the runoff into vegetated ditches. 13 ft wide x .06 ft long x .01 ft. yr x .055 tons/cu. ft. = .00043 tons/yr.

- Improve approaches
- Raise elevation of road
- Install turnouts for water diversion
