# Prentiss Creek

At Snowmobile Trail  
PRN-3

**Prentiss Creek at Snowmobile Trail**

**Site I.D.:** PRN-3

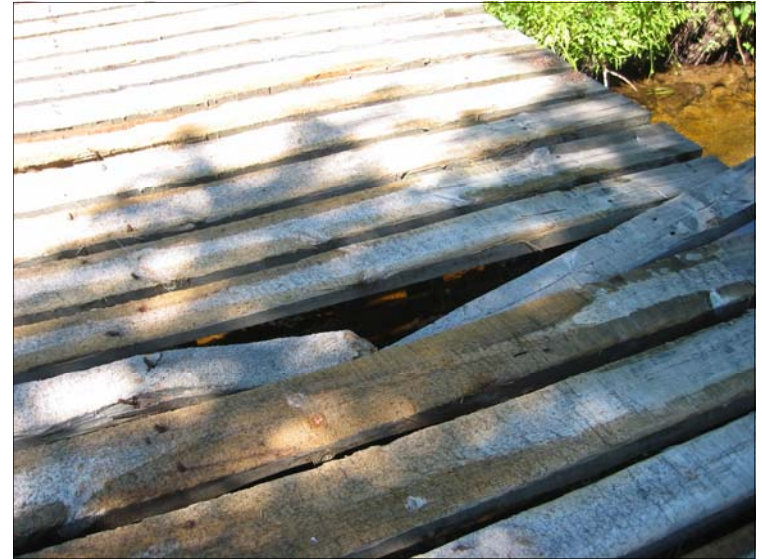
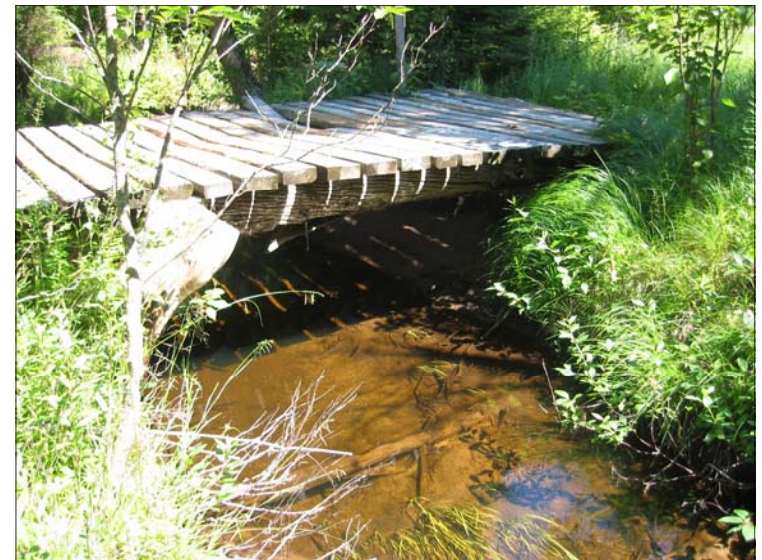
- Other conditions

**Erosion Severity Rating:** Moderate (18)**Overall Condition Rating:** Minor**Cost:** See BMP Cost Tables

**Comments:** This crossing is a simple bridge over the creek supported with cedar poles perpendicular to the creek and planks nailed over the posts. The bridge should be lengthened and thus raised over the creek so that elevated flows during spring, fall, and heavy rain events will not be impeded by the bridge. The embankments should be anchored with rip-rap and heavy vegetation to eliminate erosion at the present embankment. 14 ft long x 1 ft wide x .01 ft/yr x .055 tons/cu. ft. = .0154 tons/year

- Lengthen and raise bridge
- Raise approaches
- Install rip-rap along embankments
- Plant vegetation
