Beavertail Creek

At Prentiss Bay Road (second crossing)
BVR-4

Beavertail Creek at Prentiss Bay Road (second crossing)

Site I.D.: BVR-4

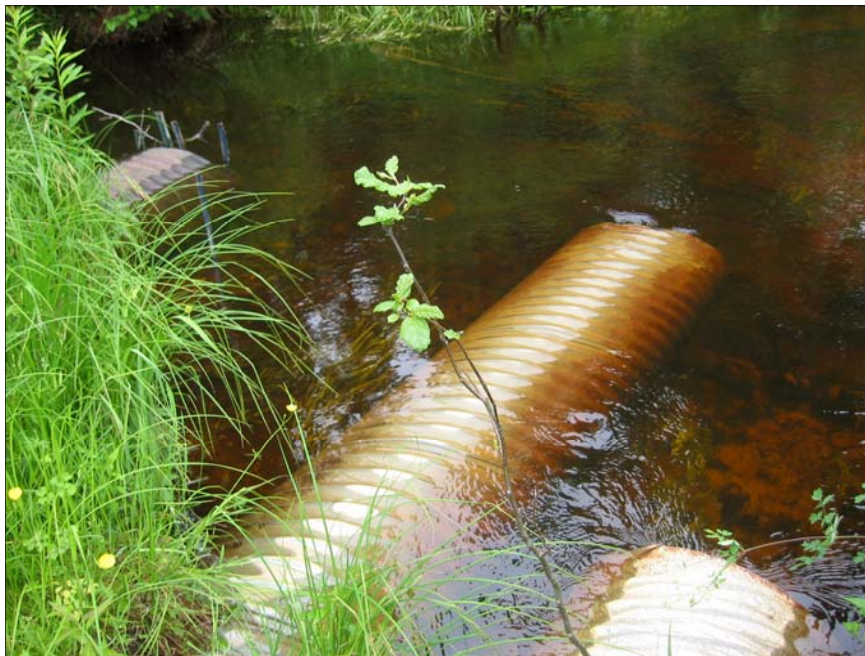
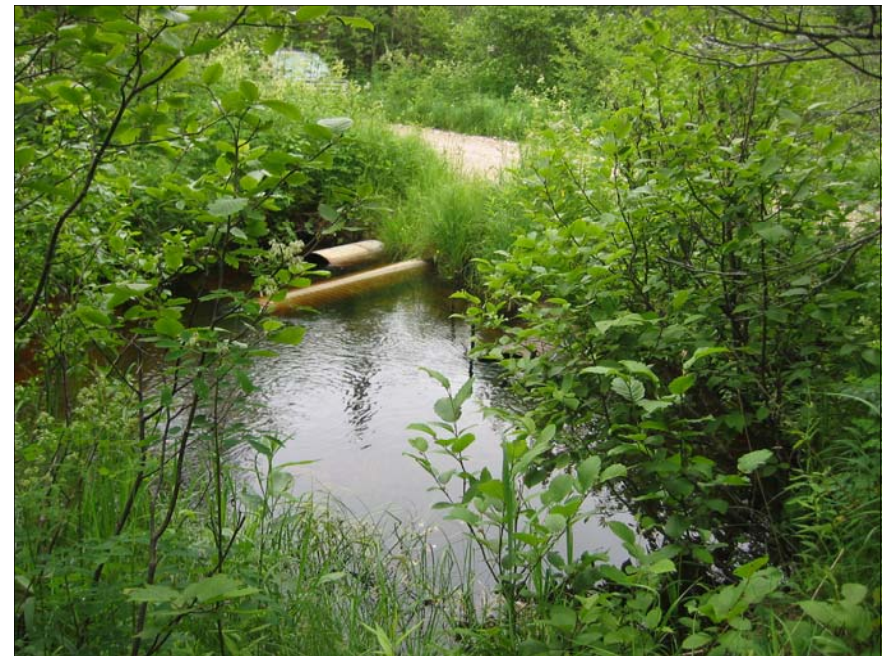
Overall Condition Rating: Severe

- Replace culverts with single bottomless culvert or bridge
- Raise road elevation
- Stabilize embankment with vegetation
