# Flowers Creek

At Flowers Bay Road (north)  
FLR-3

**Flowers Creek at Flowers Bay Road (north crossing)**

**Site I.D.:** FLR-3

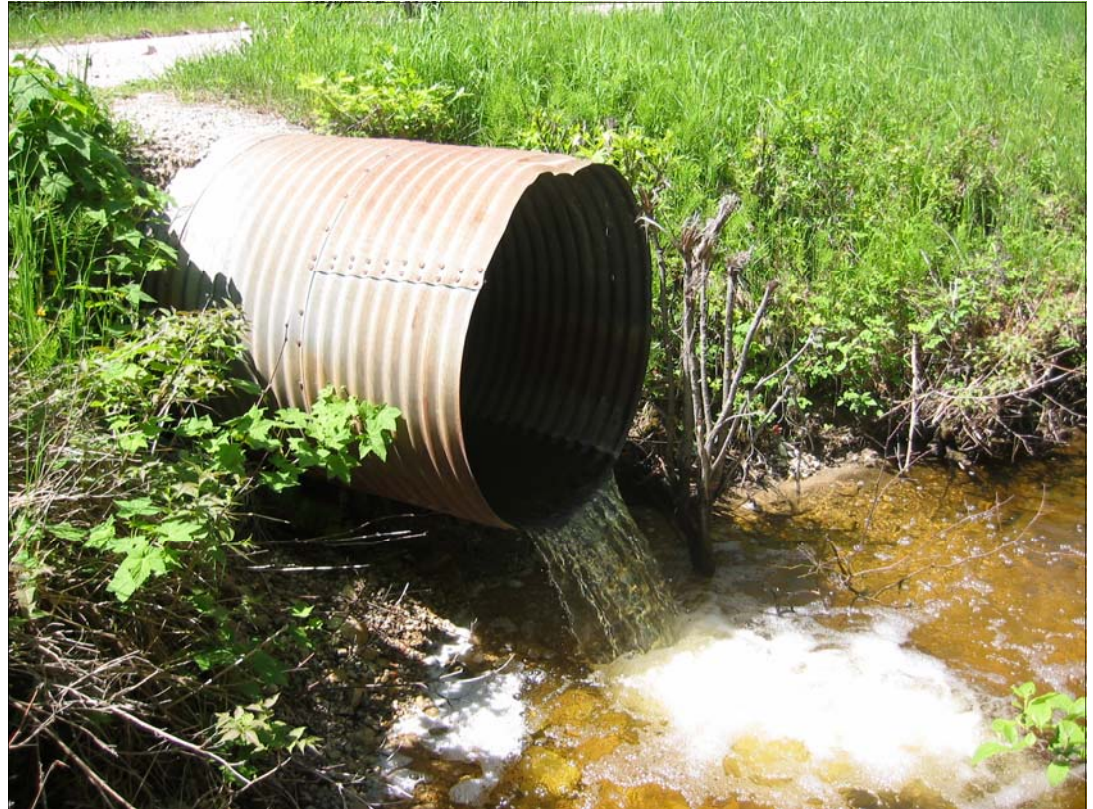
**Overall Condition Rating:** Severe

**Comments:** This culvert serves the main creek channel, but it is perched to the extent that the main discharge diverts away from it and along Flower Bay Road to cross through FLR-2. The culvert at this location (FLR-3) needs to be removed and replaced with a larger, bottomless culvert and the riparian vegetation near the crossing restored to stabilize the entire crossing. Structures should be installed along Flower Bay Road to divert road runoff into vegetated ditches before entering the creek.

- Replace culvert with bottomless culvert or bridge
- Restore vegetation to stabilize crossing
- Install structures to divert road runoff into ditches
- Stabilize lower streambank
