# Pearson Creek

at Meridian Road  
PRS-2

**Site I.D.:** PRS-2

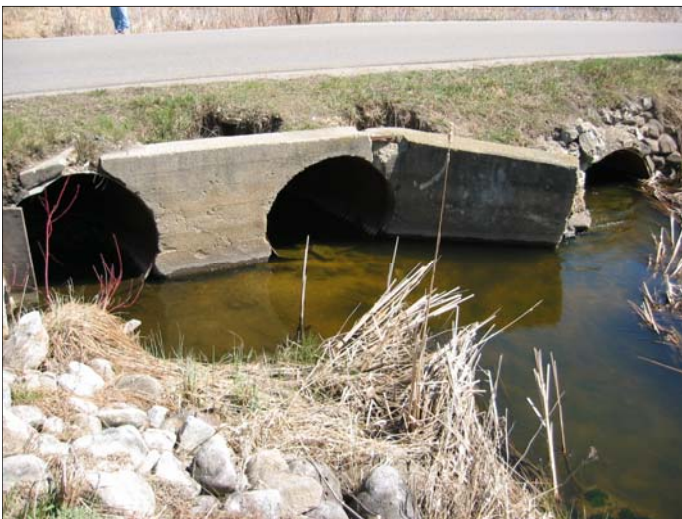
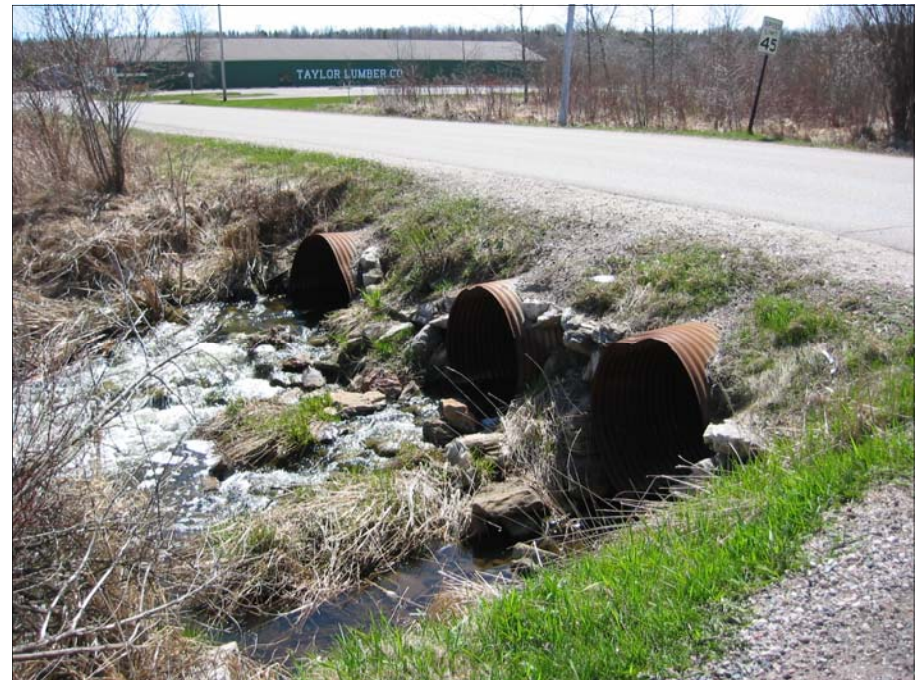
**Comments:** Pearson Creek is suffering the negative impacts of the Meridian Road crossing in downtown Cedarville. The crossing has three separated, perched culverts in which the upstream concrete embankment is separating from the roadside embankment, creating both a hazard to pedestrian and vehicular traffic as well as an erosion site. The north side stream bank on the downstream side is a vertical wall stabilized with weathered cedar posts. This riparian area, which is now a restaurant parking lot, is also in danger of collapsing and depositing sediment into the creek mouth. The preferred treatment at this site would be a bridge that would have walking access across the creek with a future pedestrian structure providing safe walking from the downtown area to the public boat launch and parking area. 2 ft wide gully(top) + 1 ft at bottom/2 x .5 ft. deep x 10 feet long x .055 tons/cu.ft. / 10 years = .0275

- Replace culverts with bridge with pedestrian/bicycle accommodation
- Reshape and stabilize
