Pearson Creek

at State Road
PRS-5

Site I.D.: PRS-5

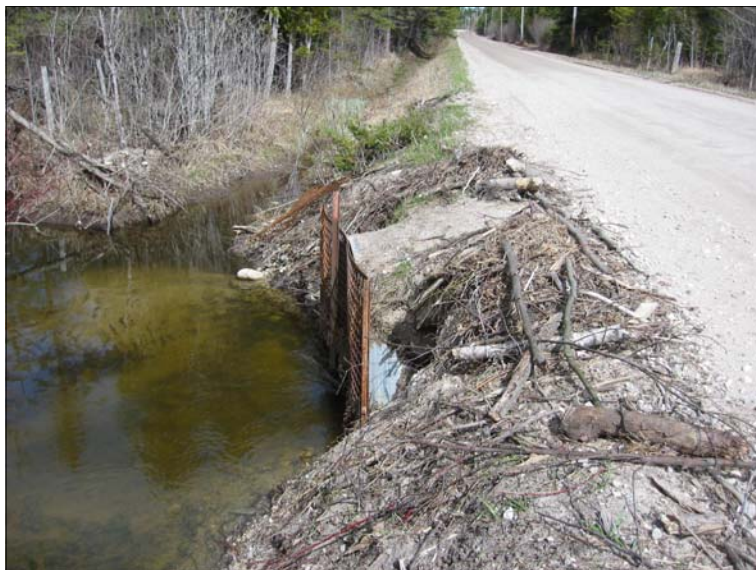
Downstream

Overall Condition Rating: Severe

- Replace culvert with bridge or bottomless culvert
- Raise the road elevation
- Raise the approach elevations
- Restore ditch vegetation
- Install diversion outlets
- Install rip-rap

Comments: It is recommended that a bridge or bottomless culvert large enough to accommodate natural creek channel be constructed at this location. The road over the bridge and at approaches should be raised and paved with structures installed to allow water to runoff road into vegetated ditches before reaching the creek. The stream bank on the north side of State Road needs to be restored with vegetation and possibly rip-rap. 10 ft long x 3 ft high x .01 ft/yr x .055 tons/cu.ft. = .165 tons/year
