Pearson Creek

Northwest Tributary at the Snowmobile Trail
PRS-8

Pearson Creek (NW Tributary) at Snowmobile Trail

Site I.D.: PRS-8

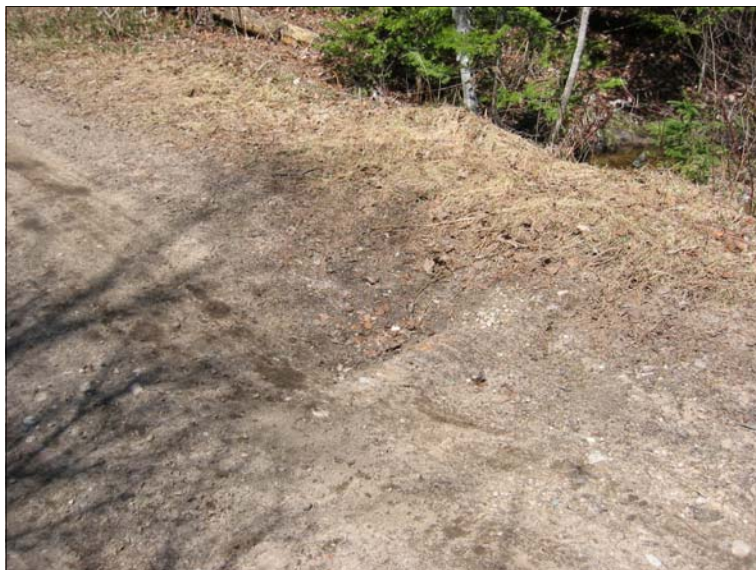
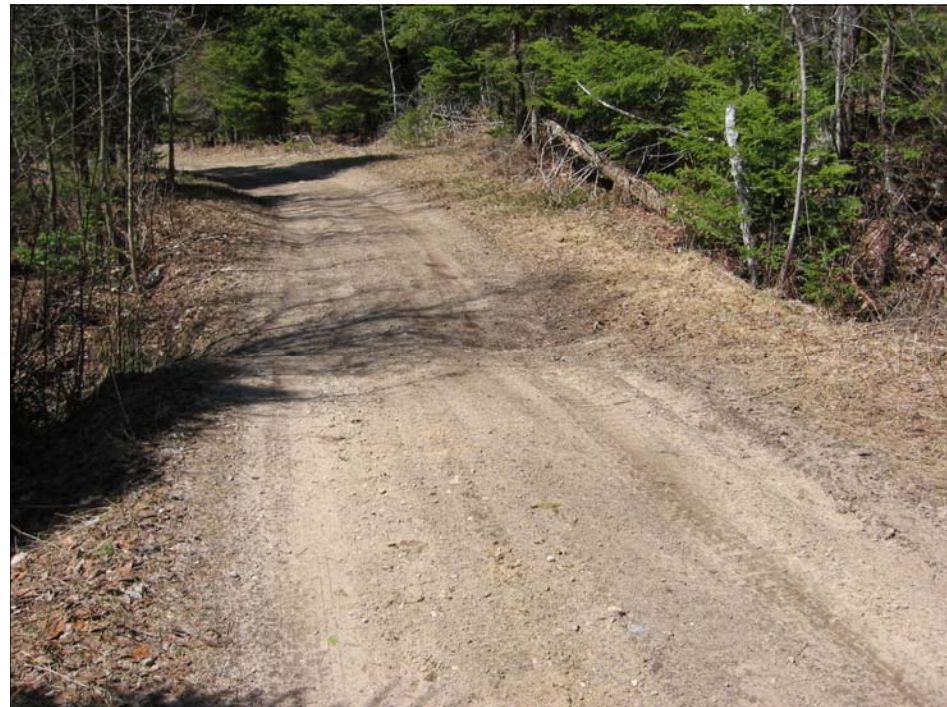
Condition: Poor

Overall Condition Rating: Severe

Comments: The road over this tributary is eroding away each time increased spring, fall, and rain event flows dam at this crossing. The culvert should be replaced with a larger, bottomless culvert to accommodate the natural course of the tributary. The length of the culvert should be increased to protect from road dirt to reach the tributary at the crossing. The approaches should be installed with runoff diversions so the road doesn't provide an easy route for runoff into the tributary. 10 ft long x 2 ft high x .03 ft/yr x .055 tons/cu. ft. = .03 tons/yr

- Replace culvert with larger bottomless culvert
- Increase length of culvert
- Stabilize embankment
- Install runoff diversions
- Revegetate
- Raise approaches
